REPORT of the GHI Buildings Committee Crawl Space Task Force

December 16, 2014

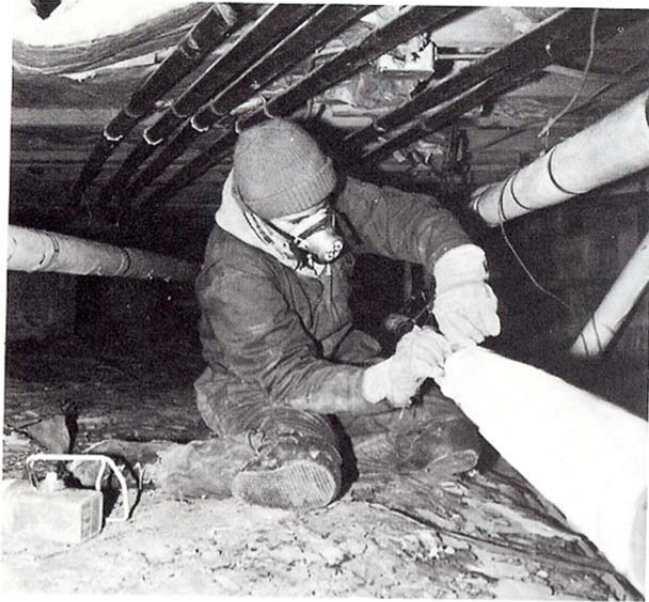
Working in the crawl space beneath a row of homes, a member of GHI's Youth Community Conservation Program is seen insulating pipes. Insulation has already been packed into the crawl-space ceiling just above head. Such work was tedious, requiring persons to spend most of the time on hands and knees as the crawl spaces vary in height from three to five feet. Photo by Don Volk

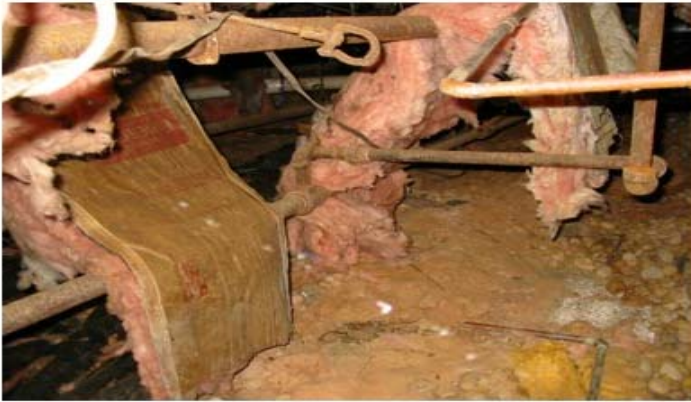
Above: Frame crawlspace c. 2004 showing Fiberglas® batt insulation, pipes and wires, and plastic vapor barrier (left) and bare clay floor (right).

Top right: Same crawlspace, showing bare sub-floor.

Lower right: Foundation vent, automatic type; uses set-screws which do not secure to masonry.

(All views from GS vent shown at lower right)

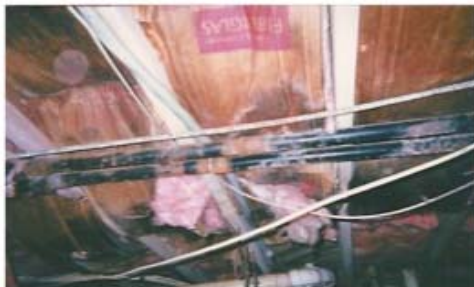
Fiberglass installed upside down

The TF recommends an approach that ideally should not require batting materials beneath the floors (instead placing minimum 2 inch rigid foam insulation along the foundation interiors, creating semi-conditioned crawl spaces with the use of mechanical ventilation). However, the TF also recommends researching alternative non-faced batting (fiberglass or rock wool) materials to insulate specific problem spots such as under kitchen or bathroom floors, or at the base of plumbing wall spaces if members still feel cold. The TF recommends making sure all holes and penetrations at the base of shared plumbing walls be sealed. (Note: Rock wool has a number of desired features that bear further investigation if batt insulation is required as part of the strategy)

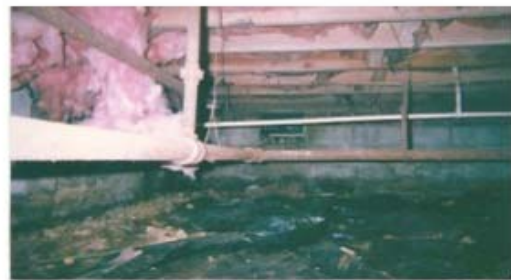
Vapor barrier not extending to wall

Polyethylene vapor barriers (essentially thick plastic sheeting) of a minimum thickness of 10 mil are recommended to replace the 3 mil thickness installed during the 1980s (some of which are torn or missing). Their purpose is to prevent water from entering the crawl space from the floor, and they should be sealed to foundation walls or any wall vapor barriers. In the pilot homes we saw, vapor barriers are sealed around the perimeter with a five-inch mound of spray foam. In the masonry homes, the crawl space walls are covered with foam board insulation, and the vapor barrier and any other seams are also sealed with spray foam.

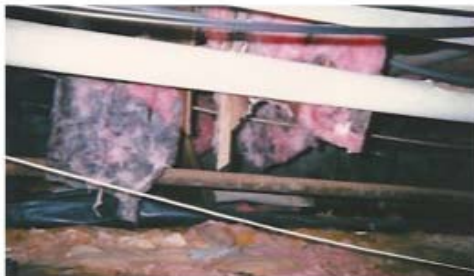
Fiberglass Batts Falling Down

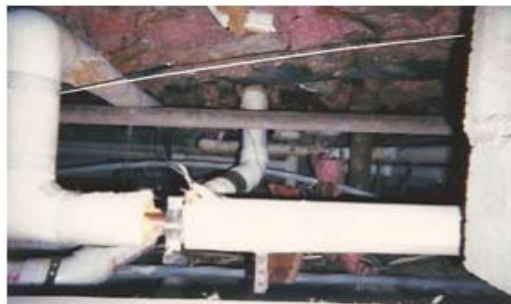
Crowded with pipes

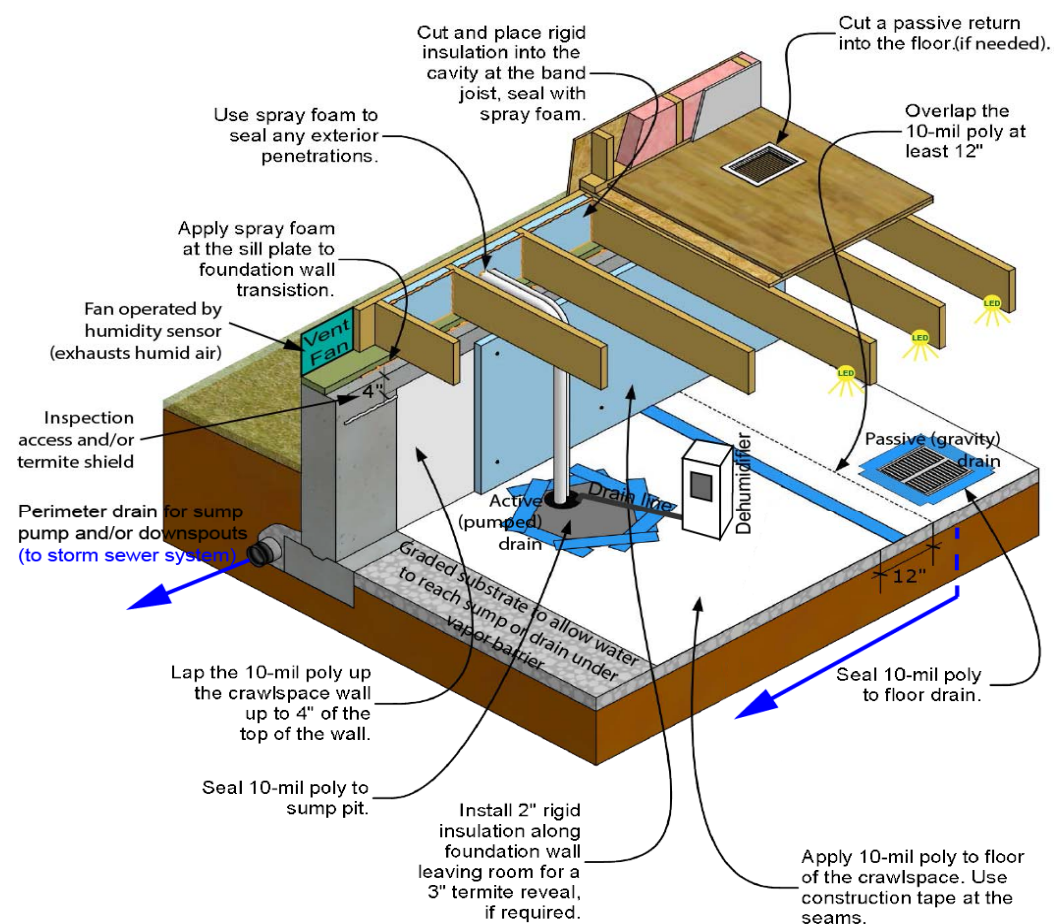
Appendix D: Sample Encapsulated Crawl Space

Figure 1 (ES). Crawl space interior details of idealized NREL frame crawl space adapted for GHI units that includes a sensor-controlled vent fan and dehumidifier and both active (sump pump) and passive (gravity drain) outlets, as appropriate, for water that infiltrates under the vapor barrier. See Figure CSTFx for details of sealed access door.

- j. Crawl space dehumidifier(s) for all unit types which require them.
- k. Airtight access doors
- l. Termite barrier strip or Termite reveal for inspections at top of rigid foam board on perimeter walls

- m. Alarm system for excess moisture
 - a. Hygrometer
 - b. Water sensor
 - c. LED alert
 - d. Audio alert
