Vents in Frame crawlspaces

Sample Frame Crawl space 2

Sample Frame Crawl Space 1

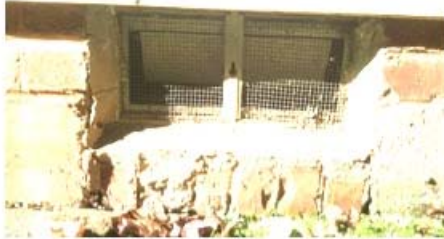
Conventional vents requiring twice-yearly GHI staff maintenance to open and close.

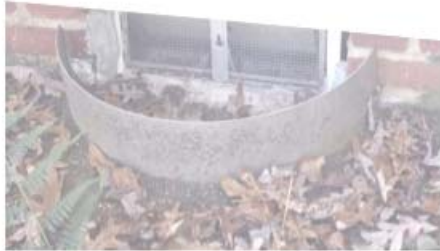
Auto vent (GHI's final fix after animal intrusion in late 2007). Vent below permanently mounted by member contractor in 2014

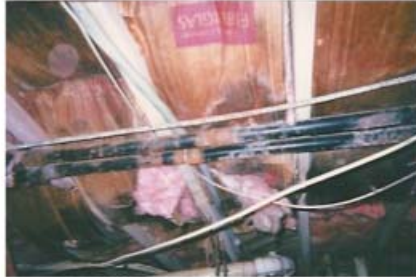
Fiberglass installed upside down

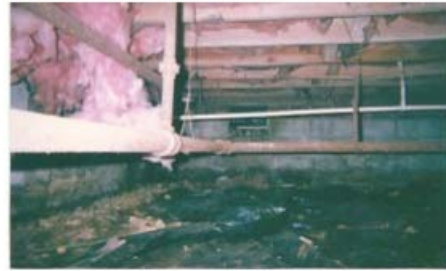
Vapor barrier not extending to wall

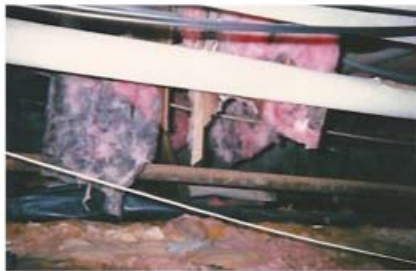
Fiberglass Batts Falling Down

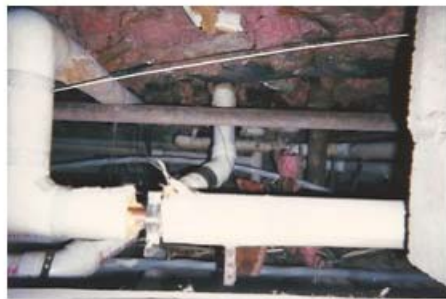
Crowded with pipes

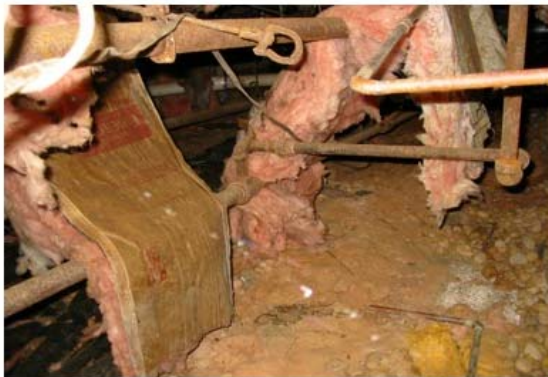
Above: Frame crawlspace c. 2004 showing Fiberglas® batt insulation, pipes and wires, and plastic vapor barrier (left) and bare clay floor (right).

Top right: Same crawlspace, showing bare sub-floor.

Middle right: Same, showing partial vapor barrier and animal scat.

Lower right: Foundation vent, automatic type; uses set-screws which do not secure to masonry.

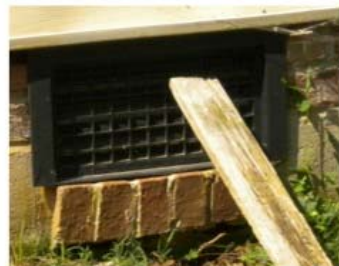
Vapor barrier is poorly installed and/or maintained in multiple masonry rows.

Pipes and utilities are a jumble, damaged hot water pipe insulation evident.

Air/vapor sealing issues at penetrations. Pests (ants/crickets) have been reported.

Foundation wall insulation doesn't extend under porches, increases conduction of cold air into the space and cools the unit above.

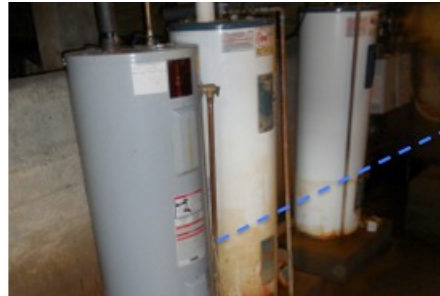
Apparent [water line](#), extensive rust on all water heater bases

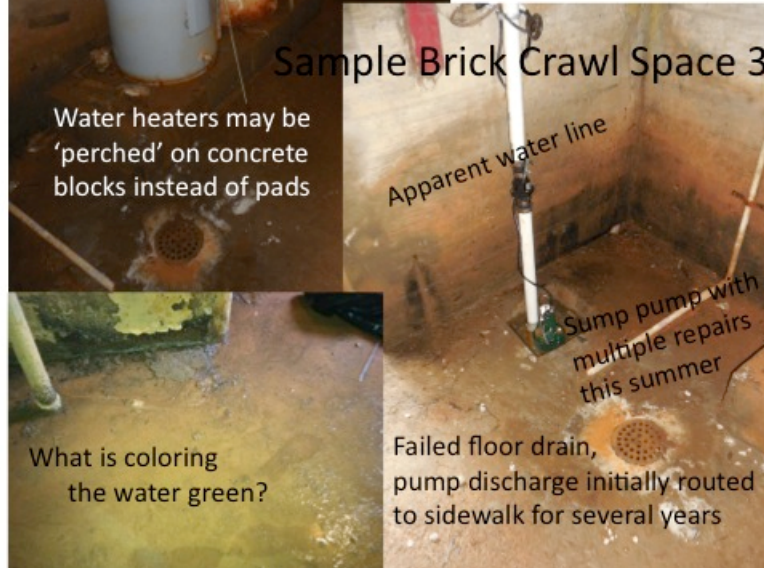
Water heaters may be 'perched' on concrete blocks instead of pads

Apparent water line

Sump pump with multiple repairs this summer

Failed floor drain, pump discharge initially routed to sidewalk for several years

What is coloring the water green?

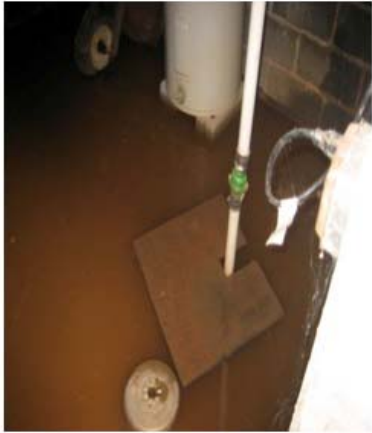
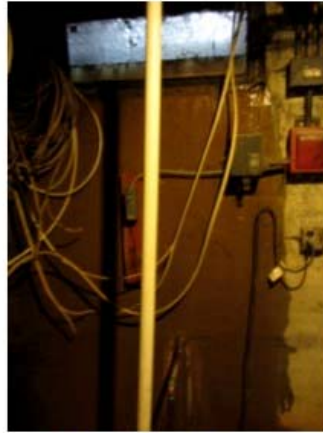
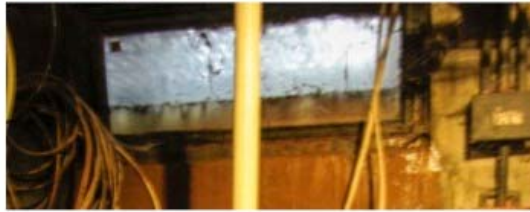
Flooding Boiler Room

Water problems developed after the passive floor drain failed many years ago. Recent flooding due to sump pump failures may have damaged electrical equipment.

Water heaters and pipes are in unconditioned space leading to excess energy use and long cold hot water runs to interior units in winter.

Odors from stagnant water are detectable in units above indicating air flow between crawl space and units.

Humidity and health impacts (mold, mildew) may persist even if vapor barrier is properly installed. Deep boiler rooms act as sumps even during dry weather periods.

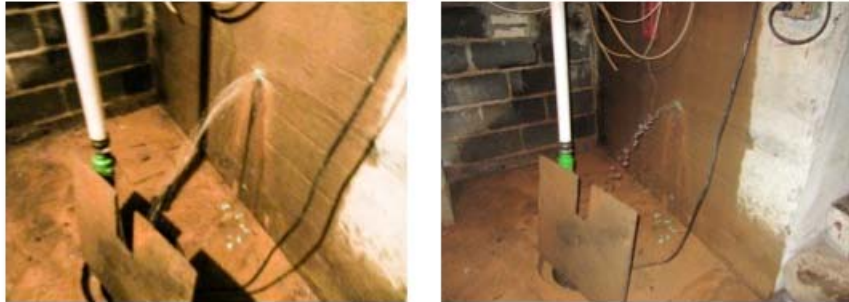
Weep Hole to Relieve Stress
