Parking Lot Rain Garden Retrofit

Site Location: Greenbelt Homes, Inc., Greenbelt, Maryland

Project Site Description: Private residential parking lot encompassing approximately 12,000 square feet and providing parking for 42 vehicles.

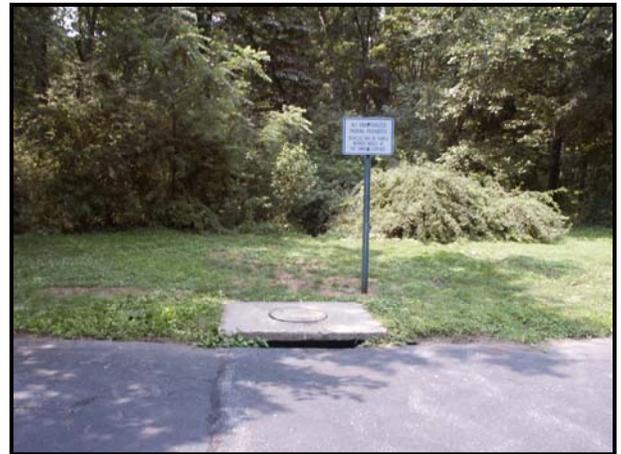
The parking lot surface was deteriorated and due for major reconstruction. The existing storm water catch basin serving the lot had deteriorated and the asphalt curb at the basin was crumbling causing ponding of water in the lot and muddy conditions in adjacent grass areas. (Figure 1a) Extensive head cutting and erosion was present at the storm water outfall contributing to stream degradation in adjacent forest conservation area parcels. The area surrounding the storm water outfall was overgrown with invasive shrubs and vines and was a frequent site of trash dumping. (Figure 1b)

Figure 1a. Original Site Conditions

Reconstruct parking lot to include a rain garden bioretention retrofit for the site to divert and capture a majority of rainfall runoff and promote infiltration to reduce negative impact to headwater stream system. Install a concrete curb with inlets to direct storm water toward the infiltration basin and construct a concrete-bypass structure to accommodate proper drainage in large storm events. Landscape entire area with native trees, shrubs, and wildflowers to beautify site and discourage future trash dumping.

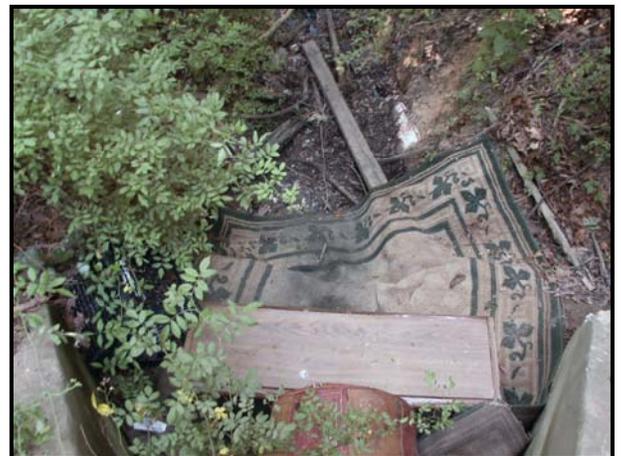
Figure 1b. Original Drain Outfall

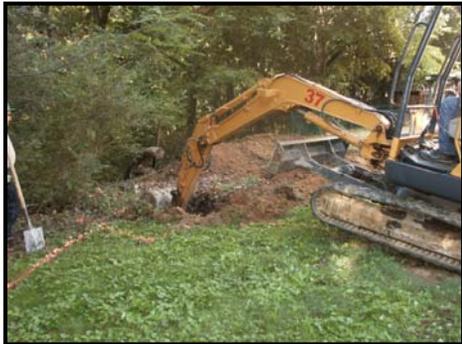
The first phase of construction involved excavating the garden site with a backhoe and forming the outline of the garden. (Figure 2a) During the excavation, the contractor carefully located and exposed the existing drain pipe that would be connected to the new drain by-pass structure. (Figure 2b) Most of the existing soil was removed from the site but some was retained to form the berm around the garden perimeter which would create a ponding area for rainfall runoff from the parking lot. (Figure 2c) In total approximately 30” of soil was excavated.

Figure 2a. Initial Excavation

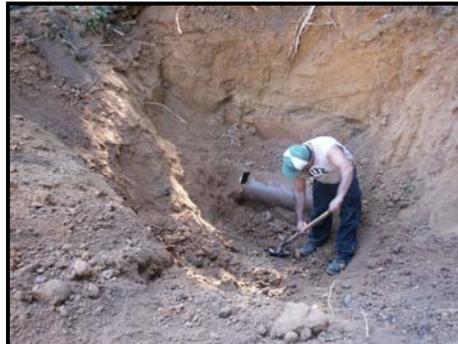
Figure 2b. Existing Drain Pipe

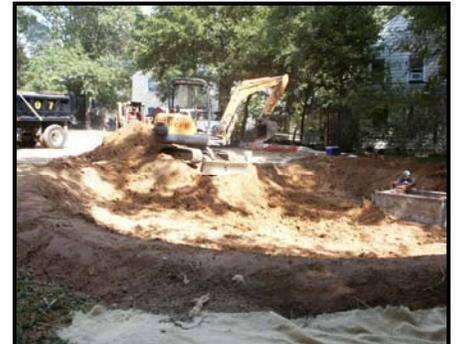
Figure 2c. Forming berm

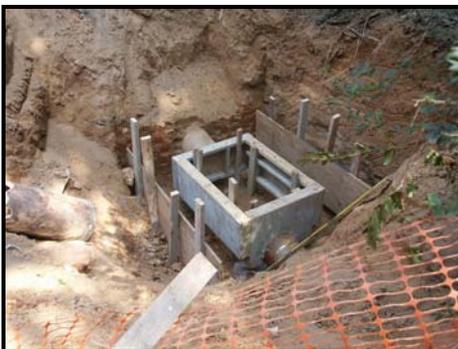
Once the drain pipe was located, the contractor began the second phase of constructing the drain by-pass which allows excess rain water to drain off during heavy rain storms. (Figure 3a) The drop-structure forming the by-pass was constructed from poured concrete. (Figure 3b) Forming and pouring the new concrete curb for the parking lot also took place at the same time. (Figure 3c) This step was the first portion of the parking lot restoration component of the project.

Figure 3a. Drain by-pass structure

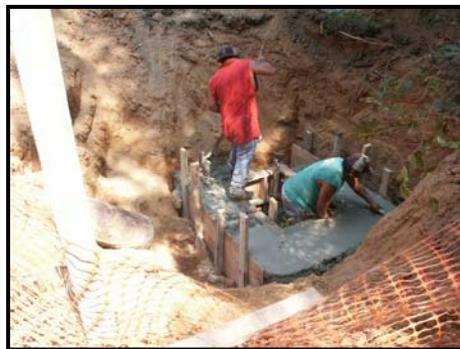
Figure 3b. Pouring by-pass

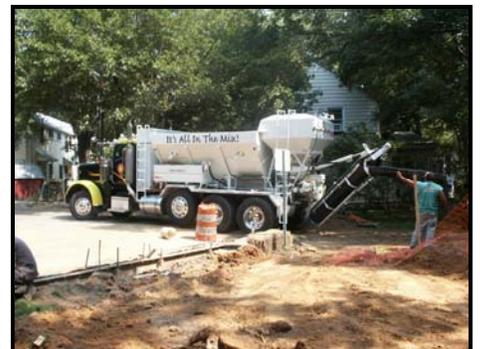
Figure 3c. Pouring parking curb

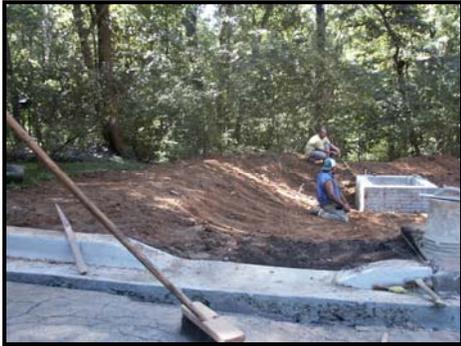
The third phase involved identifying the correct height for the top of the drain by-pass and berm to ensure a 6-8” ponding depth for the garden at final grading. (Figure 4a) Then staff shaped and compacted the clay soils of the berm. (Figure 4b) This step is important to harden the berm which acts as a levee to hold ponding water in the garden area. Staff then leveled the existing sub-soil in the garden to prior to adding the new garden medium. (Figure 4c)

Figure 4a. Leveling by-pass

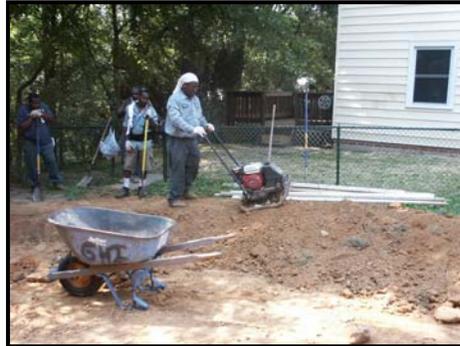
Figure 4b. Compacting berm

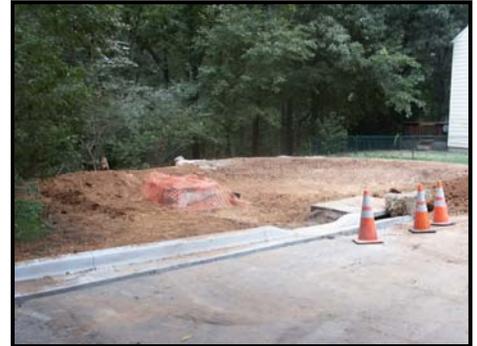
Figure 4c. Garden Profile

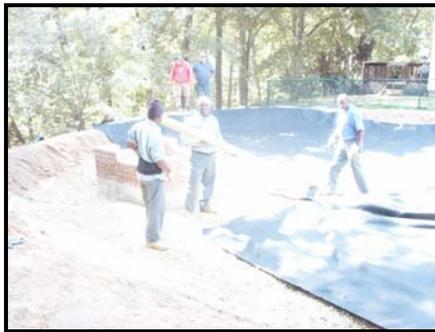
The fourth phase was to install the drainage and growing medium. CPE, Inc. assisted GHI staff to install approximately one foot of ¾” wash gravel to improve drainage. GHI staff leveled the gravel and installed a fabric silt barrier on top. (Figure 5a) Next CPE and staff installed a specially designed bioretention soil mix containing high organic material and coarse sands to promote good plant growth. (Figure 5b) Staff leveled the grade of the garden to ensure a ponding depth of approximately six inches from the garden soil and the top of the berm. (Figure 5c)

Figure 5a. Install fabric barrier

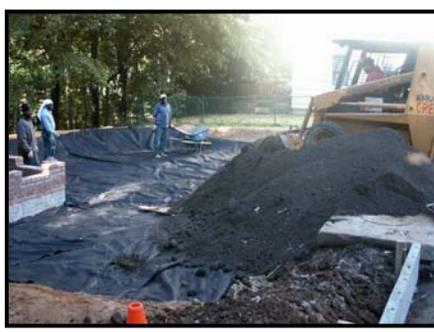
Figure 5b. Install soil mixture

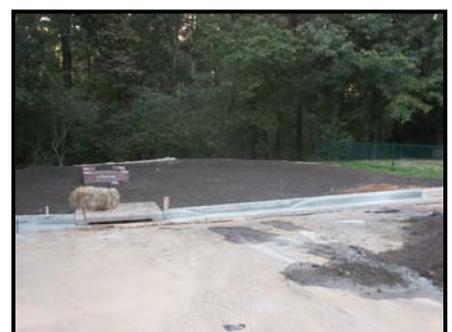
Figure 5c. Final garden grade

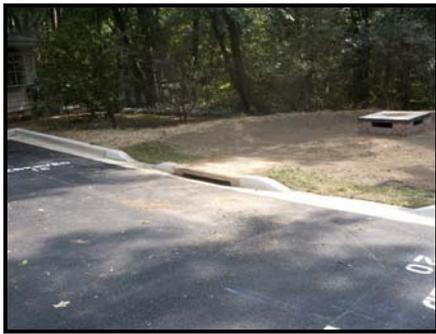
The sixth phase of the project was to install plant material in the garden and surrounding berm area. Staff planted a sod buffer strip in the garden at each of the curb cuts to help slow the flow of water into the garden and seeded the berm perimeter with a fast-growing fescue grass mix (Figure 6a.) GHI then installed a coconut fiber erosion control blanket on the back berm of the garden (Figure 6b) and planted the slope with a mix of native shrubs and grasses to stabilize soils. (Figure 6c)

Figure 6a. Grass filter

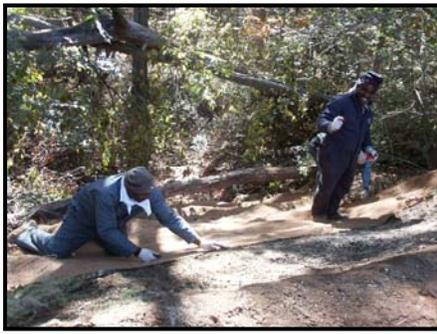
Figure 6b. Erosion fabric on berm

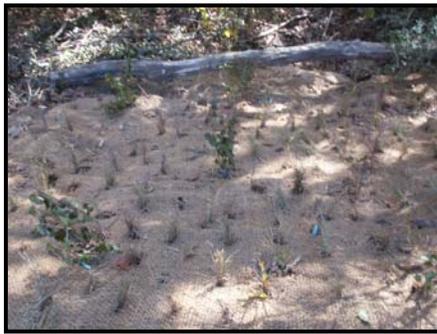
Figure 6c. Planted back slope

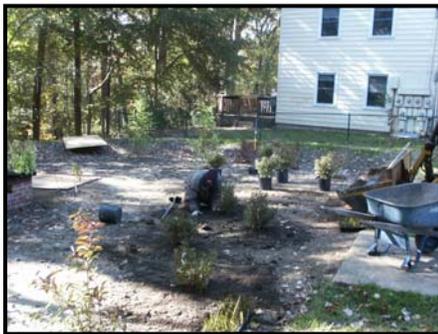
The sixth and final phase was planting and mulching the garden bed and installing the final signage. Planting took place in two steps over a period of several days. During the first step, GHI staff installed 35 native trees and shrubs according to the design plan. (Figure 7a) The second step entailed planting more than 900 native wildflower and grass plugs. (Figure 7b) Lastly the garden was mulched with a 2-3” layer of shredded hardwood mulch and the informational sign installed. (Figure 7c)

Figure 7a. Planting shrubs

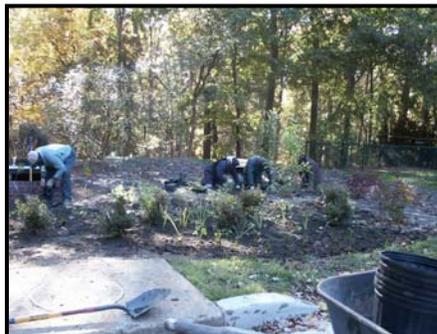
Figure 7b. Planting wildflowers

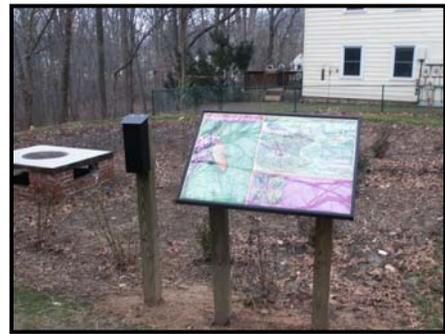
Figure 7c. Educational signage

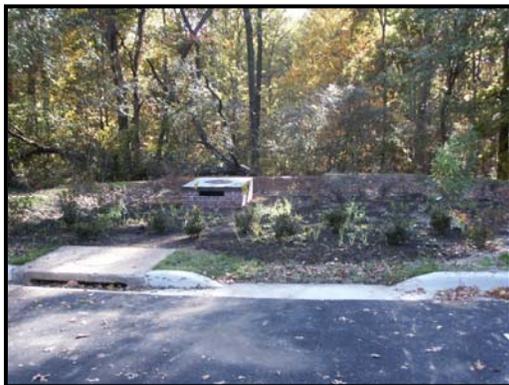
Final Garden- Initial Year

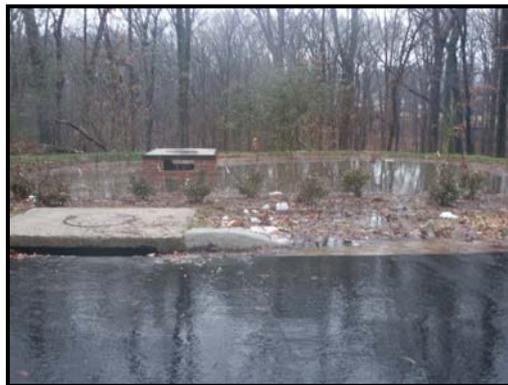
Final Garden- After rainstorm
