REPORT of the GHI Buildings Committee Crawl Space Task Force

December 16, 2014

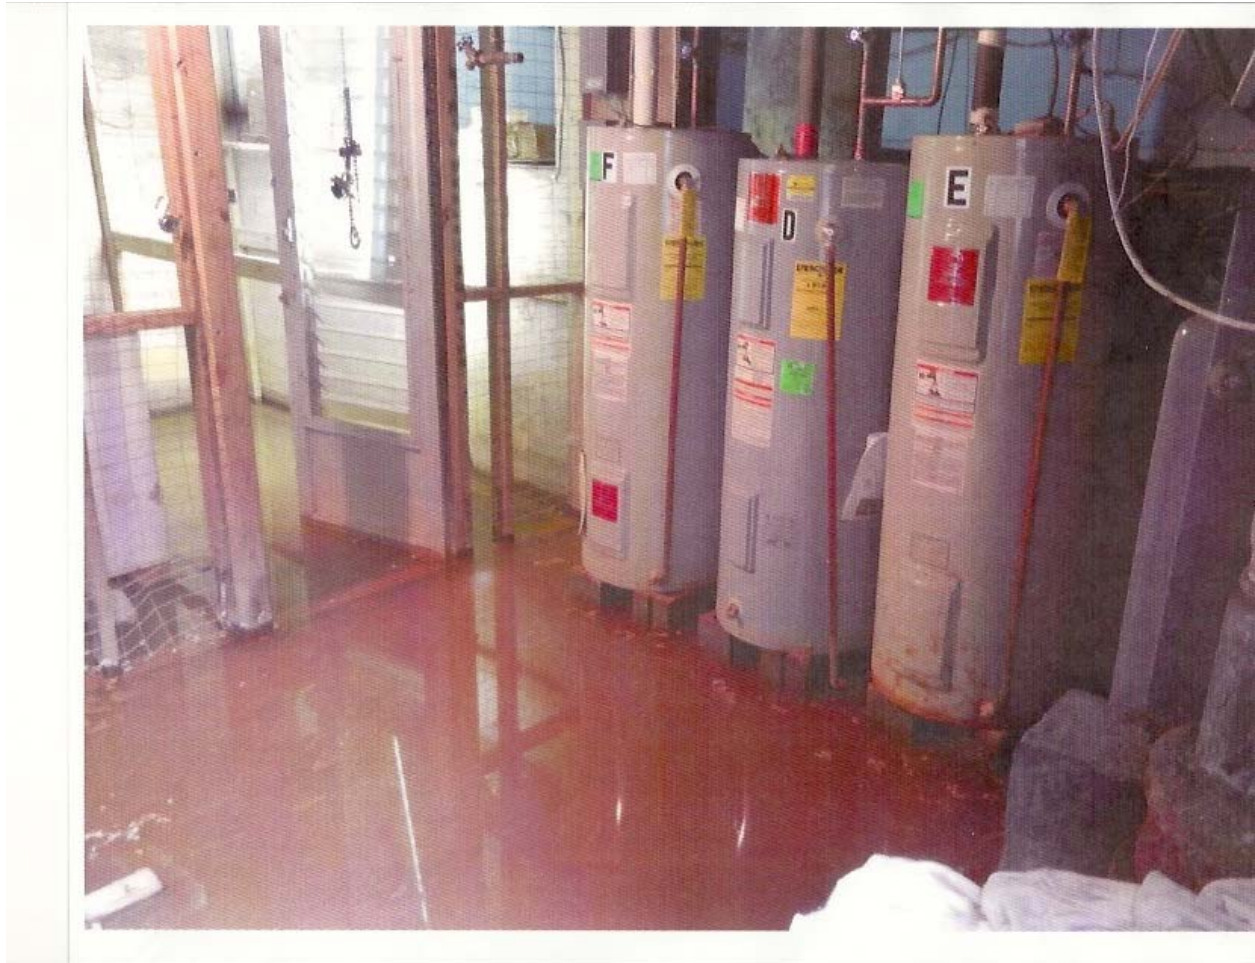
Masonry buildings also have a major water intrusion problem that needs to be dealt with. A major source seems to be failing interior drainage systems located in the boiler rooms. Typically the floor of the boiler room is located much deeper than the floors of the adjacent masonry crawl spaces. This floor can be up to 8-12 feet below grade. These rooms can act as giant sumps for water during major storms. Failed storm systems can allow water to back up into the passive drain systems causing boiler room to flood. This is in particularly true where exterior passive drainage systems have been corrupted over time such as swales being degraded by weather events or simply by members filling in swales. Additionally waterproofing that was applied to foundations when originally built degrade over time. There is at least one block unit that had water infiltrate main unit because of this degradation. Other boiler rooms have window wells where seals have failed around window allowing water to infiltrate boiler room. Also, there is at least one masonry building, which has so much water pressure allowed to build up against foundation during heavy storms that a weep hole has been creating, allowing water to pour into building's sump. This water is then evacuated by sump pump. Every time this building has a power outage during a storm boiler room floods because sump no longer functions. This building has two basements. These basements will also flood when boiler room floods.

RECOMMENDATION: *Masonry buildings should be sealed and insulated along the perimeter. Appropriate vapor barrier should also be installed properly. Most of the recommendations that apply to frame buildings should be applied to masonry buildings as well. See frame recommendations for complete description. Ventilation fan might not be required in masonry buildings because ceiling of crawl spaces are concrete which effectively seals boiler room and crawl spaces from living space. However all penetrations at the base of common party walls should be sealed in the building's crawl space and boiler room. Also, all plumbing and electrical penetrations in kitchen areas and other locations should be sealed.*

RECOMMENDATION: *All buildings that have flooding when there is a power outage during a storm should have some sort of backup system installed for sump pump(s).*
